Monitoring Data Record

Project Title: R-2000G (I-540) COE Action ID: 199920387

Stream Name: UT Neuse River (Site 10) DWQ Number: 030114

City, County and other Location Information: I-540, Wake County (Sta.460+53 -L- to 459+80 -L- RT.)

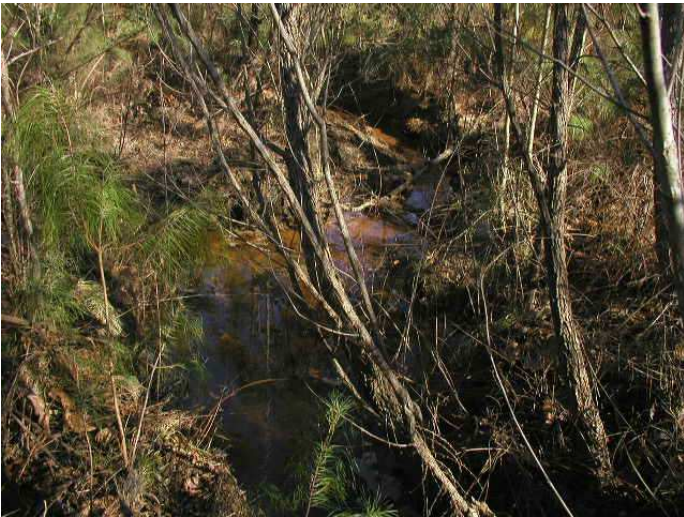
Photo Point #1 (Downstream)

Date 1/13/11	Sta. 1+50 - RPC- Photo Point #1 Downstream	Sta. 1+00 -RPC- Additional Photo	Station Number	Station Number	Station Number
Structure Type					
Is water piping through or around structure?					
Head cut or down cut present?		Headcut has formed			
Bank or scour erosion present?	Bank scouring on left bank				
Other problems noted?

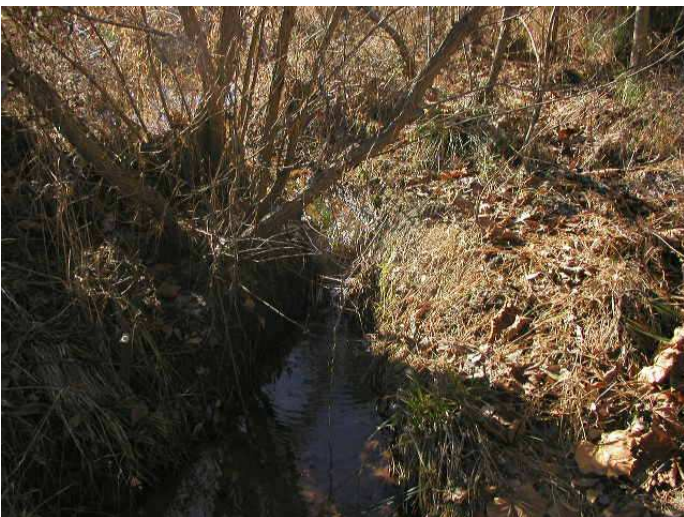
The UT Neuse River is experiencing some localized areas of instability but overall the stream relocation is stabilized for the Year 5 Winter evaluation. The beavers and dams that were noted during the last monitoring evaluation have been removed and these areas are stable at this time. An area of bank scouring was noted along the left bank at Sta. 1+50 -RPC- and a headcut has formed at Sta. 1+00 -RPC-. NCDOT will continue to monitor this stream relocation to see if remedial action is warranted.

Headcut has formed b/t Photo Points 3 and 4 (Sta. 1+00 -RPC-)
